FORD TECHNICAL SERVICE BULLETIN 03-16-1

Engine Controls/Fuel System - MIL ON/DTC's P0171/P0174

**Article No.
03-16-1**

**FORD:
1999-2003 WINDSTAR**

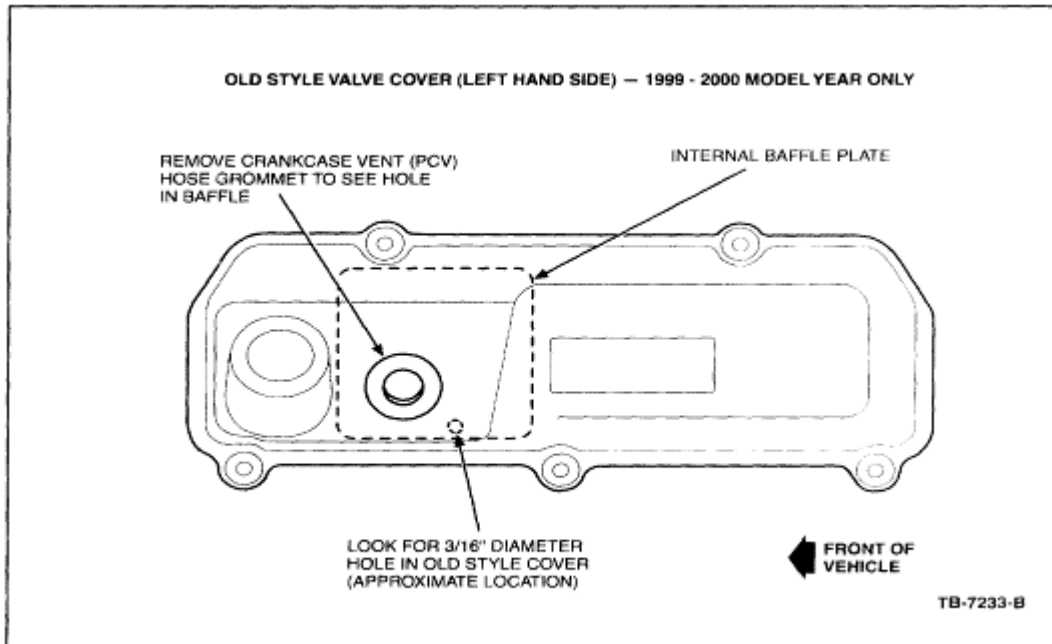
Figure 1

NOTE USING A SHOP LIGHT OR FLASHLIGHT, CHECK THE LH VALVE COVER TO SEE IF IT HAS ALREADY BEEN UPDATED TO THE LATEST LEVEL. REMOVE THE PCV VALVE AND RUBBER GROMMET FROM THE VALVE COVER AND LOOK THROUGH THE HOLE AT THE INTERNAL SHEET METAL BAFFLE. THE OLD STYLE VALVE COVER BAFFLE HAS A 3/16" DIAMETER HOLE IN THE 5:00 O'CLOCK POSITION AS YOU LOOK THROUGH THE PCV HOLE (FIGURE 1). VALVE COVERS FITTING THIS DESCRIPTION MUST BE REPLACED.

2. (ALL 1999-2003). Reprogram the PCM (Powertrain Control Module) with the latest calibration, WDS B26.2 release or later. Do not replace the PCM. Reset the keep alive memory.
3. (1999-2001 ONLY). Inspect the vacuum line from the intake manifold to the fuel pressure regulator for looseness, leaks and/or oil contamination and replace Vacuum Line (XF2Z-9E498-DD) if required.
4. (1999-2000 ONLY). Inspect the LH Valve Cover, it should be a (3F2Z-6582-BA) Install a new LH Valve Cover if required, refer to Workshop Manual Section 303-01 Valve Cover-LH. (Refer to the following NOTE for description of the old style valve cover).
