ODI RESUME

Investigation: EA 05-005
 Prompted By: PE04-078
 Date Opened: 03/22/2005
 Date Closed: 08/02/2006
 Principal Investigator: Bruce York
 Subject: Engine Compartment Fires

ENGINEERING ANALYSIS CLOSING REPORT

SUBJECT: Speed Control Deactivation Switch Fires.

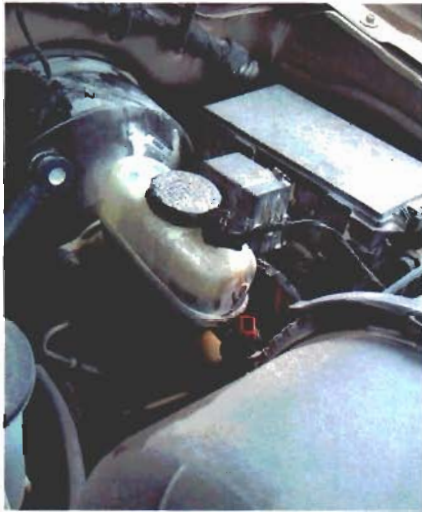
ALLEGED DEFECT: Failure of the speed control deactivation switch that results in switch overheating or fire (Figures 1. and 2.).

Figure 1. SCDS Fire Initiation.

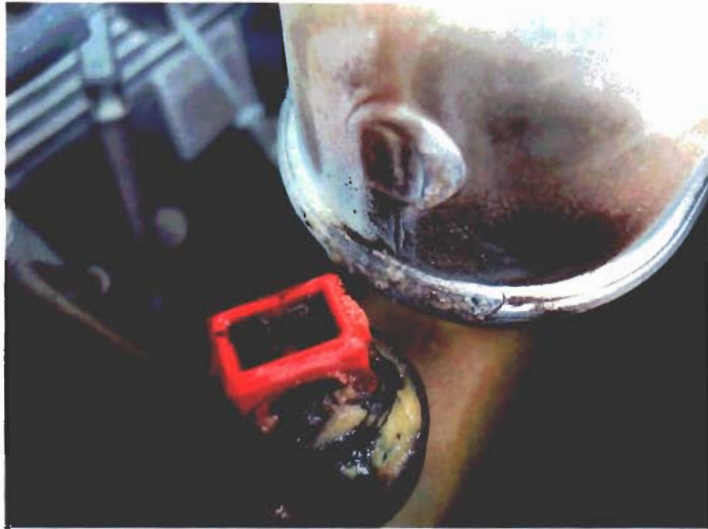
Figure 2. SCDS Fire Initiation Close Up.

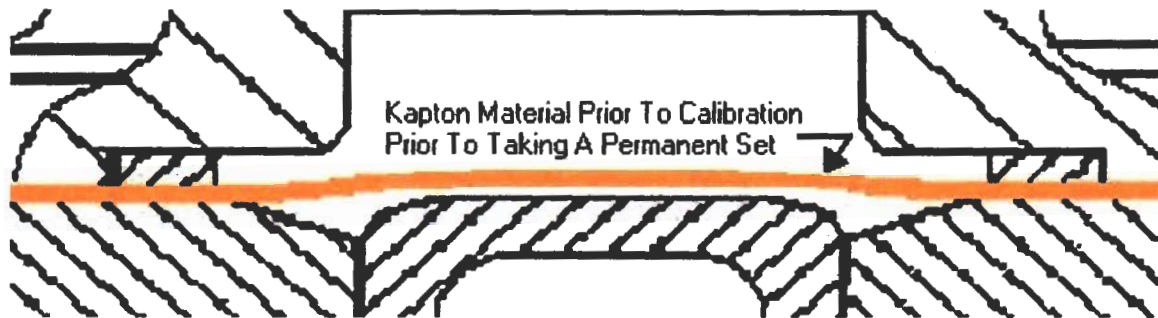
In order to maintain stable calibration settings on the switches, the manufacturer applies one or more pressure cycles to the switch. These pre-calibration pressure cycles cause the Kapton diaphragm material to take a permanent “set” where the material conforms to a “valley” formed by the button on the converter and the washer (Figure 12.). Figures 4. and 5. show cross sections of the Kapton material inside the SCDS. Figure 4. shows the Kapton as it exists just after the SCDS is assembled. Figure 5. shows the permanent set taken by the Kapton after having been through the calibration test.

Figure 4. Kapton As Manufactured Condition.

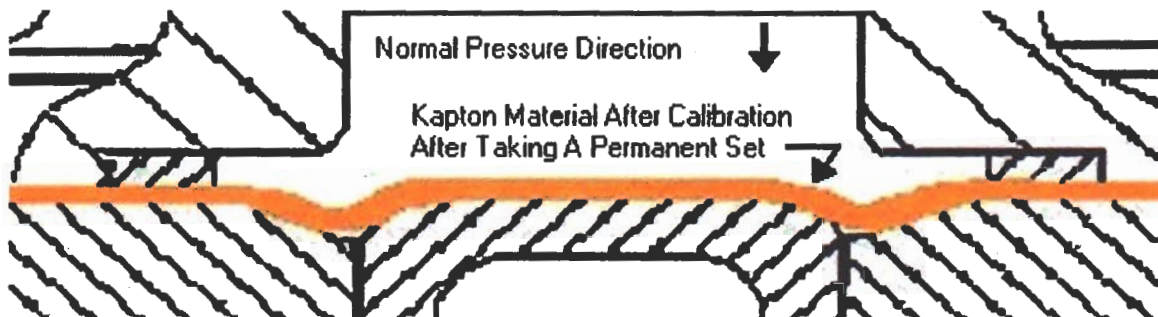
Figure 5. Kapton With Permanent Set

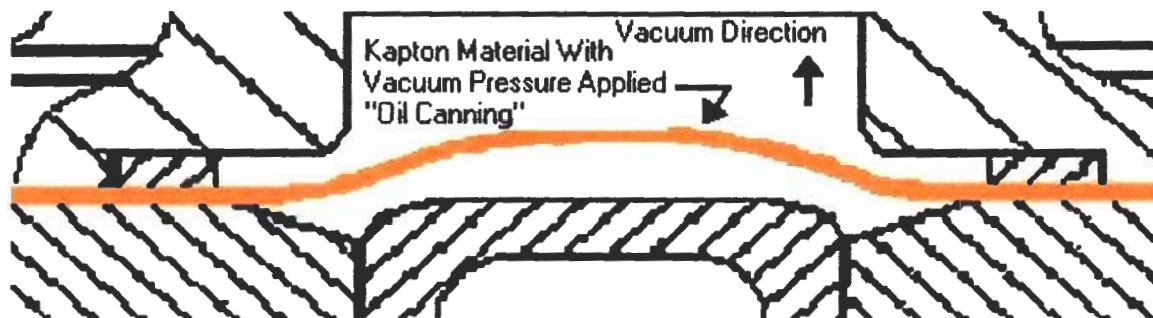
Impulse cycle testing is performed on the switches in order to demonstrate that the switch is capable of surviving the expected lifetime of brake applications on the vehicle. However the design specifications apparently did not account for a vacuum pressure experienced by some Ford model vehicles just after a braking event, when the brake pedal is released by the driver. The duration and magnitude of the vacuum pressure varies from model to model and model year to model year. In some models the magnitude of the vacuum pressure is great enough to cause the Kapton “set” to invert or “oil can”. This change in orientation of the Kapton material each time the brake pedal is released causes the Kapton material to fatigue and wear out much sooner than if the diaphragm had only experienced pressure applications in one direction. Figure 6. shows the Kapton orientation when a vacuum pressure is being applied.

Figure 6. Kapton With Vacuum Applied.

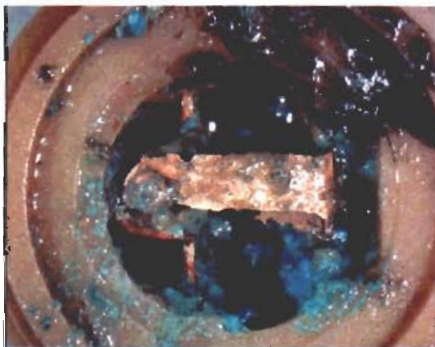
ODI and Ford both developed testing programs involving filling the base of a SCDS containing the electrical contacts with brake fluid. The contacts were then connected to a power supply and the switch was monitored. The brake fluid along with corrosion products contained in the electrical cavity created an electrolytic cell (Figures 10. and 11.).

Figure 10. Corrosion Of Electrical Contacts.

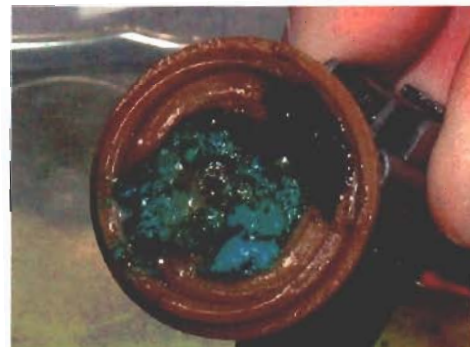
Figure 11. Electrolysis Products.

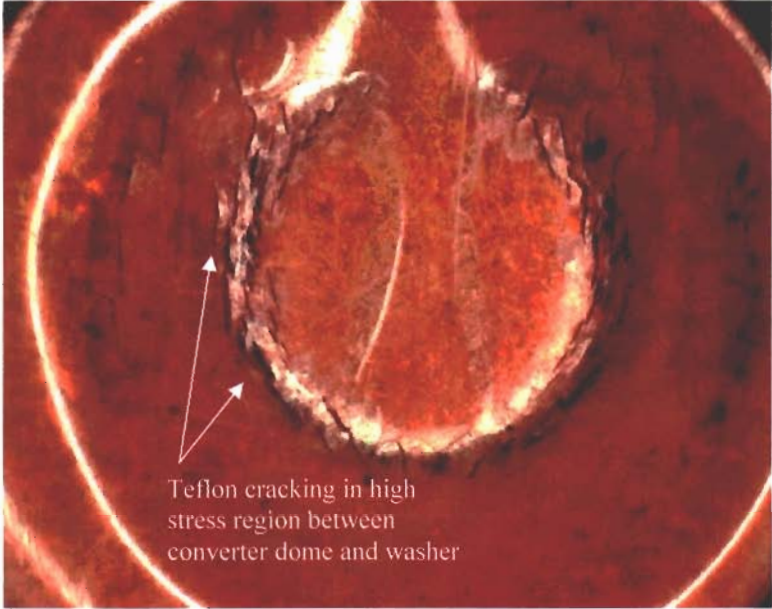
The leak results from fatigue failure of the Kapton allowing brake fluid to move from the hydraulic side of the switch to the electrical side of the switch. Fatiguing of the Kapton diaphragm results in cracks initiating in the Teflon layer (Figure 13.) of the laminate. Once the Teflon layer has been breached, the Kapton is then compromised by the water that is contained in the brake fluid. DuPont, the manufacturer of the Kapton material, indicates that hydrolytic degradation of the Kapton can be caused by water-contaminated brake fluid penetrating a cracked Teflon layer. A Kapton substrate that has been degraded from such exposure can become brittle and crack. Figure 14. shows a Kapton crack that appears to have resulted from fatigue imposed by over cycling the material.

Teflon cracking in high stress region between converter dome and washer

Figure 13. Teflon cracking.

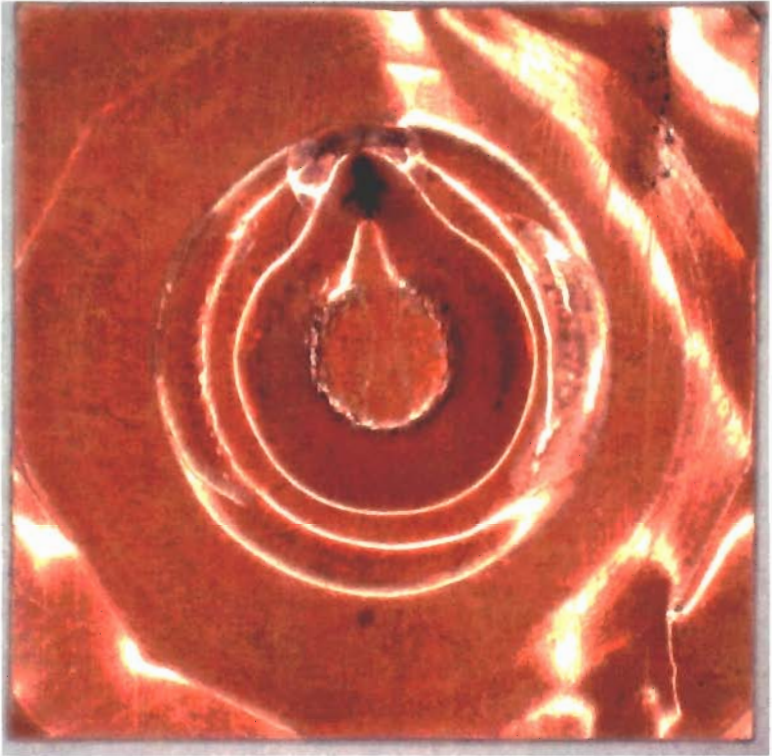
Figure 14. Crack through Kapton substrate with "Tear Drop" failure pattern.

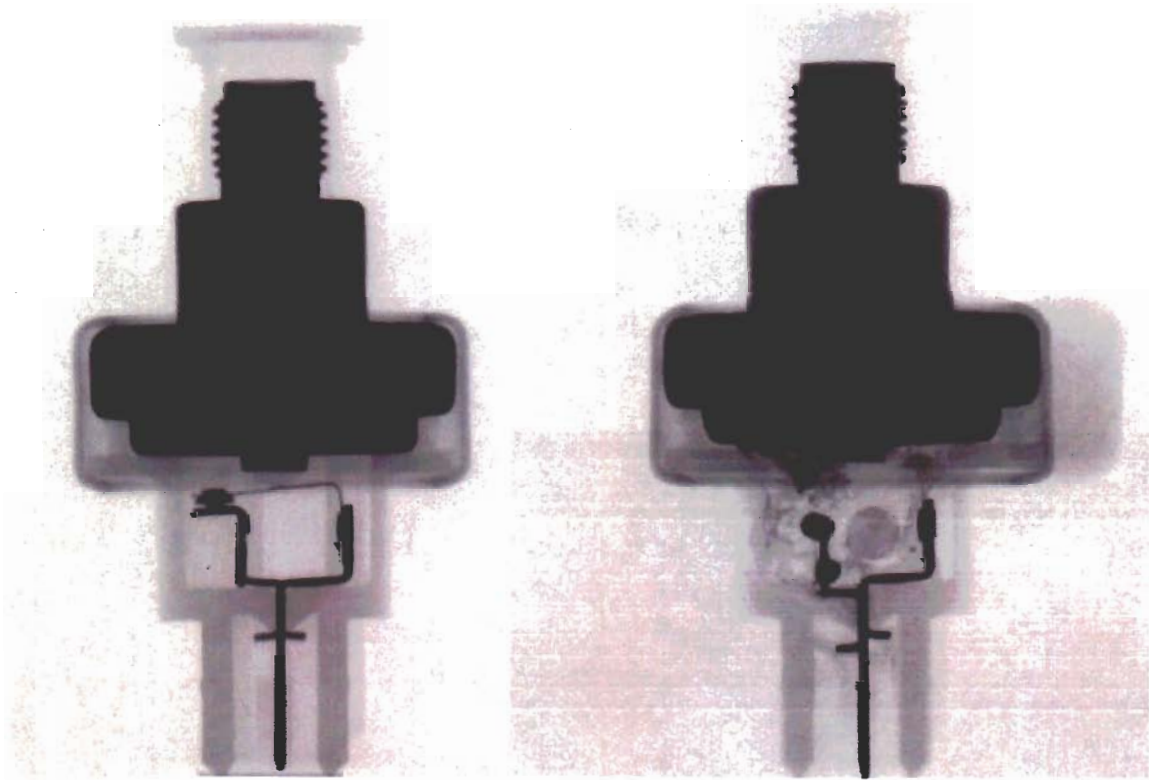
Examples of arc generated brass and copper beads and the resulting melted base of a failed SCDS can be seen in x-ray images and photos of a failed switch obtained by ODI from a complainant's vehicle (Figures 15. and 16.). This x-ray image is one of over fifty that ODI has taken of failed switches that have been collected from complainant vehicles. These x-ray images are consistent with ODI's analysis and the analyses performed by and for Ford.

Figure 15. SCDS electrical cavity before and after contact corrosion and arcing.

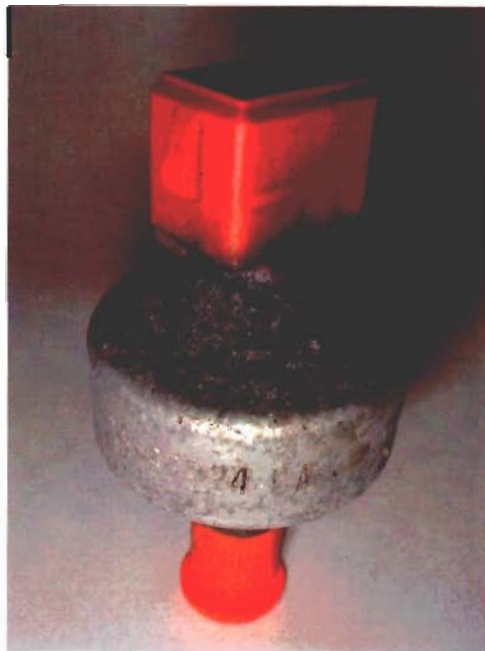
Figure 16. SCDS with melted base.

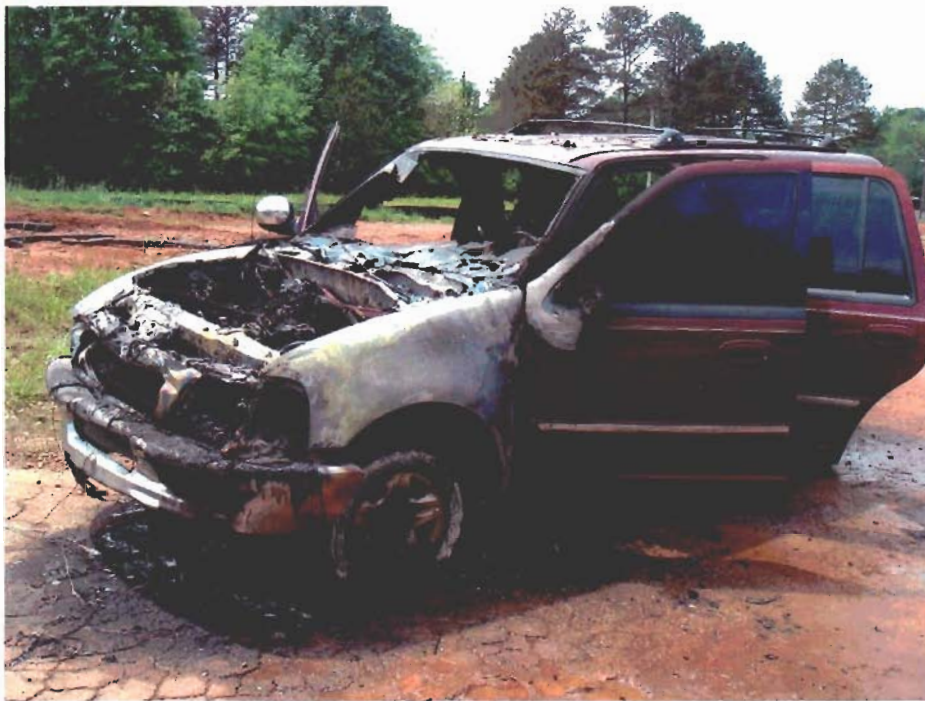
ODI observed four live vehicle burn tests to assist in determining if a fire reported to the agency was likely caused by the SCDS, and to prove that a SCDS could start a fire that could spread to the rest of the vehicle. The live burn tests were started by using a defective SCDS that was on the verge of catching fire. The vehicles were instrumented with under-hood cameras and 6 thermocouples located throughout the engine compartment. The vehicle fires were also video recorded from the exterior. The data and burn patterns collected from this series of live burns showed that a defective SCDS could catch fire and the fire could then spread to the remainder of the vehicle. The under-hood cameras and thermocouples documented how the fire spread, how hot certain areas got and how long it took for certain areas of the engine compartment to get involved in the fire (Figure 18.). This data, along with the burn patterns that were documented

after the fires were extinguished (Figure 17), were used as a reference in evaluating complainant vehicle fires. Along with eye witness testimony, owner interviews, and physical evidence, the fire test data assisted ODI in determining if a complainant vehicle fire was likely to have been caused by a defective SCDS.

Figure 17. Burns Patterns On Test Vehicle.
