WARNING! WARNING!

Are You Really Getting What You're Paying For?

“Airing” Our Grievance: Why More Air is a Problem

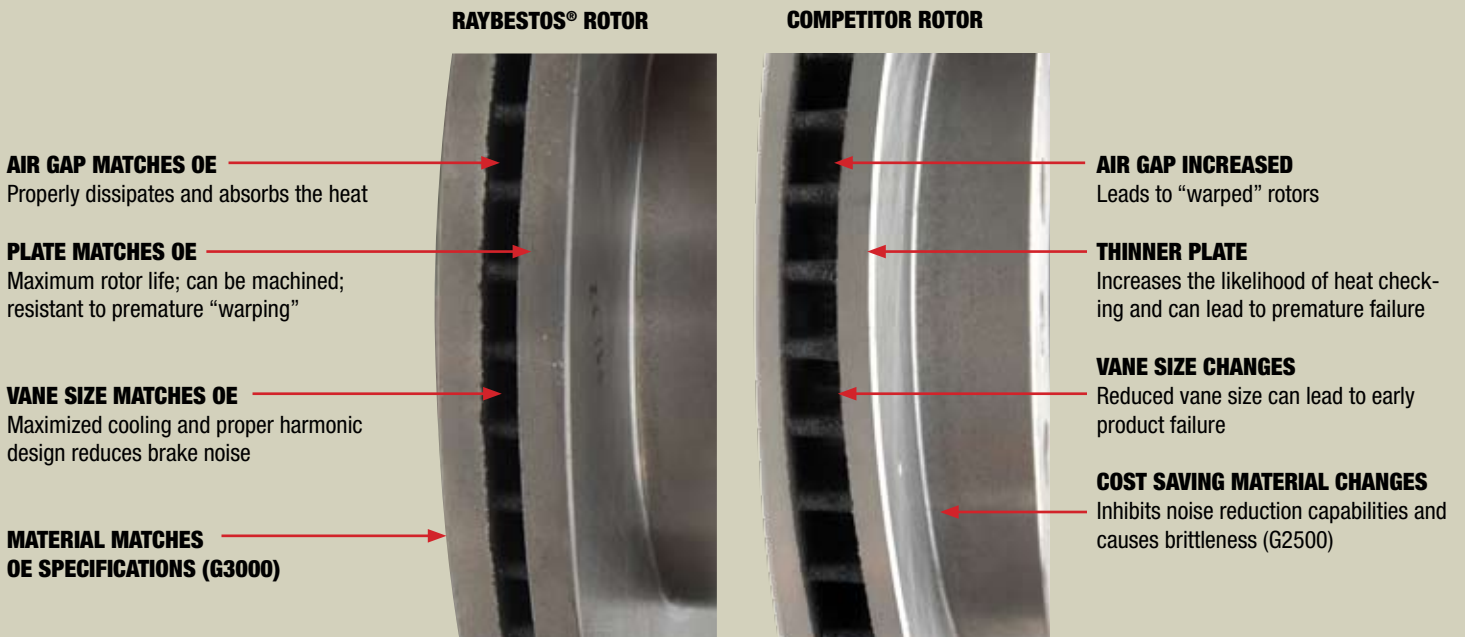
Increasing the air gap in a rotor reduces the product weight. With less mass to absorb and dissipate the heat, the rotor is likely to “warp” causing the driver to feel pedal pulsation.

These thinner surface plate rotors do not meet OE specifications and drastically increase the likelihood of “heat checking” (tiny cracks on the surface of the rotor). The reduction in the ability of the rotor to dissipate heat will cause the strength of the material to weaken and potentially cause the collar to crack. This loss of rotor mass may cause poor braking which can effect overall performance and safety.

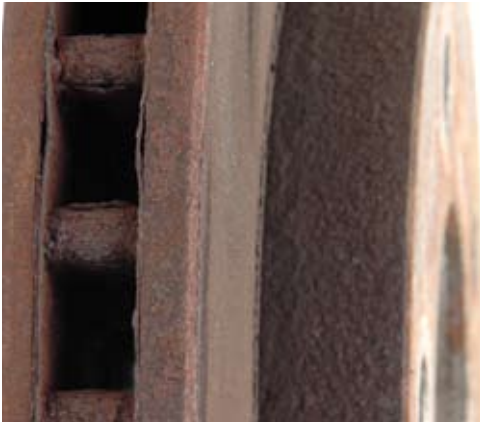
ROTOR WITH SEVERE RUST IN THE VANES

In severe climate conditions where rust is prevalent and vane dimensions have been reduced, the deterioration rate of the vanes can be accelerated with exposure to salt or calcium chloride commonly used in winter road conditions. Such conditions, combined with reduced vane sizes, can seriously reduce rotor life while simultaneously increasing the potential for failure.

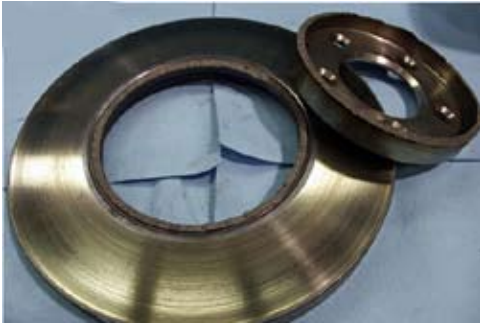
EXCESSIVE HEAT CAUSES CASTING FAILURE

In addition to plate gap variations, we at Raybestos® brand are seeing dimensional changes and reductions in “lightweight” competitors vane configurations. The reduction in vane mass causes material strength to decrease at the vane/surface plate interface and can lead to the possibility of early product failure.

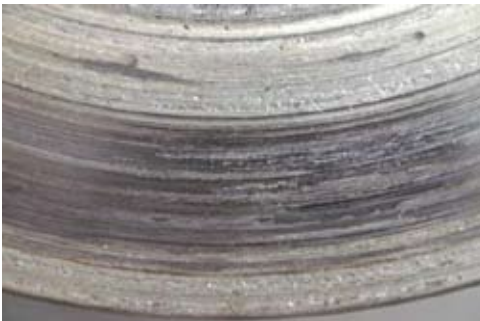
In a braking system, Raybestos® brand rotors act as a conduit to dissipate heat. Brake pads are designed to perform best at optimal temperatures. As rotor dimensions and materials vary from Original Equipment specifications, brake pad performance is directly impacted by heat. Overheating of the brake system causes brake pads to have excessive and premature wear, friction material transfer, an unresponsive pedal caused by brake fade and the potential for significant increase in noise and poor brake performance.

BRAKE PAD WEAR/FAILURE AND ROTOR SCORCHING

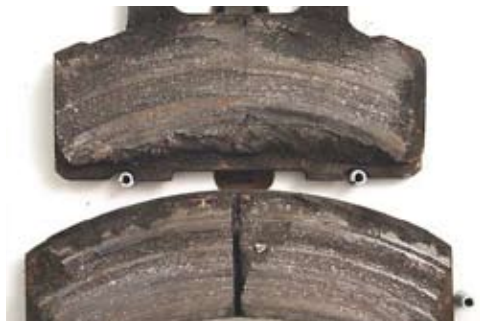
Brake noise or squealing is most often associated with brake pads, but by increasing the air gap, changing the vane configuration, reducing the weight and changing the material (to take cost out)....the harmonics of the rotor have been changed from the OE design and as a result, the “lightweight” competitors product will be significantly more noisy!

REMEMBER...WATCH OUT FOR “LIGHTWEIGHT” ROTORS

Changing the mass of the rotor by reducing the brake plate thickness has a negative effect on the thermal resistance to conductive heat flow. Heat flux into the rotor is inversely proportional to thermal resistance to conduct heat flow. Reducing the heat flux by reducing the mass increases thermal resistance, therefore causing the rotor to become hotter during operation. This will result in brake fade, “warpage,” pedal pulsation, rotor cracking, uneven friction wear, material transfer and reduced friction pad life.
