ODI RESUME

Investigation: EA 05-005
 Prompted By: PE04-078
 Date Opened: 03/22/2005
 Date Closed: 08/02/2006
 Principal Investigator: Bruce York
 Subject: Engine Compartment Fires

ENGINEERING ANALYSIS CLOSING REPORT

SUBJECT: Speed Control Deactivation Switch Fires.

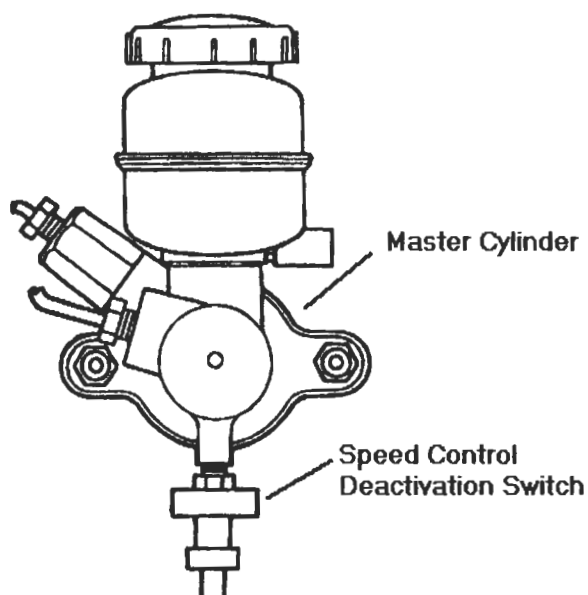
Figure 7. SCDS Vertical Down.

SCDS Orientation. Orientation of the SCDS as mounted in the Master Cylinder is another factor contributing to the alleged defect. When the electrical contacts start to corrode and corrosion products, metallic debris, and electrolysis products start to form, they move downward in the solution inside of the electrical cavity. These corrosion products move downward as a result of being denser than the brake fluid solution. Normal vehicle vibration also helps facilitate the downward settling of these products. In order for the short circuit to develop, these corrosion products must settle in such a way that dendrite growth might start and develop. When the SCDS is mounted in the master cylinder in a vertically down orientation (Figure 7.) it is believed that the metallic corrosion products settle in the plastic base of the switch completely away from the grounded hexport body. With the metallic debris settled away from the grounded hexport body, dendrite growth is inhibited and a short circuit does not develop. When the SCDS is mounted in a vertically up or angled down orientation (Figures 8. and 9.), the metallic corrosion products can settle in such a way that dendrite growth can develop.

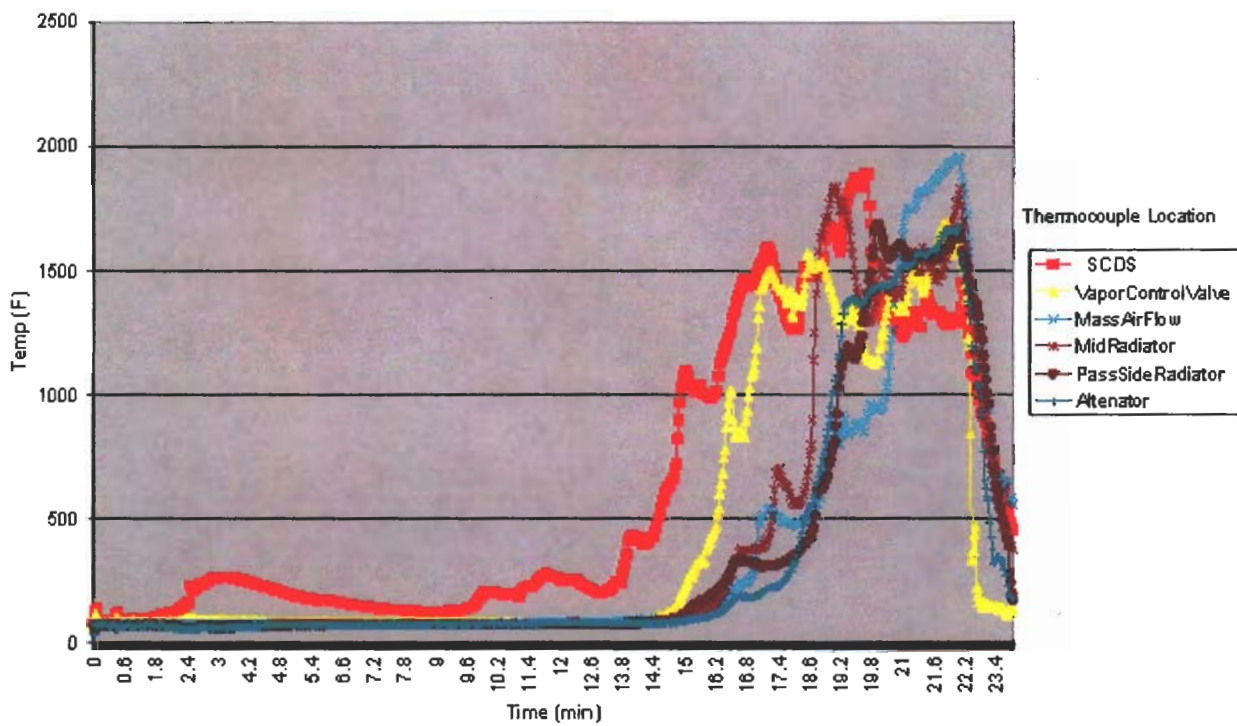
Figure 18. Thermocouple Data From Live Burn Test Vehicle.

ODI observed four live vehicle burn tests to assist in determining if a fire reported to the agency was likely caused by the SCDS, and to prove that a SCDS could start a fire that could spread to the rest of the vehicle. The live burn tests were started by using a defective SCDS that was on the verge of catching fire. The vehicles were instrumented with under-hood cameras and 6 thermocouples located throughout the engine compartment. The vehicle fires were also video recorded from the exterior. The data and burn patterns collected from this series of live burns showed that a defective SCDS could catch fire and the fire could then spread to the remainder of the vehicle. The under-hood cameras and thermocouples documented how the fire spread, how hot certain areas got and how long it took for certain areas of the engine compartment to get involved in the fire (Figure 18.). This data, along with the burn patterns that were documented

after the fires were extinguished (Figure 17), were used as a reference in evaluating complainant vehicle fires. Along with eye witness testimony, owner interviews, and physical evidence, the fire test data assisted ODI in determining if a complainant vehicle fire was likely to have been caused by a defective SCDS.

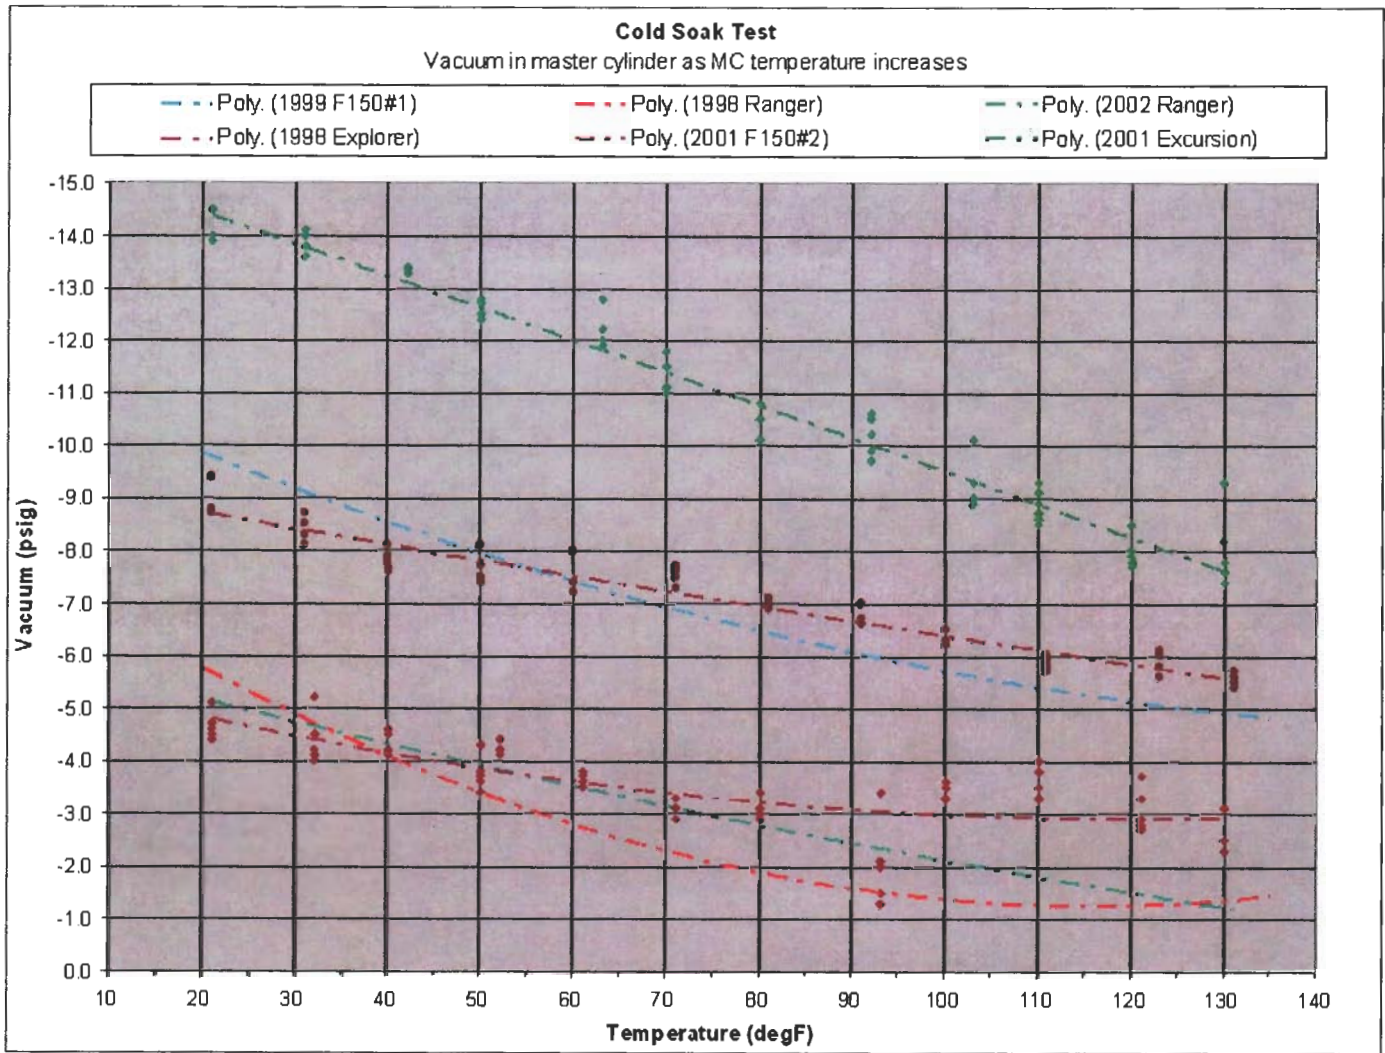
Figure 19. Temperature Controlled Vacuum Test Data.

Vacuum Testing. Conclusions from the work NIST performed were that the Kapton diaphragms were failing as a result of fatigue. ODI examined data that showed a slight vacuum at the end of the brake system pressure cycle on some Ford vehicles. This vacuum data was the result of testing that had been completed for an issue unrelated to this investigation. The review of this data initiated the decision to test if some level of vacuum in the brake system might flip or "oil can" the Kapton diaphragm. VRTC configured a SCDS so that both pressure and vacuum could be applied to the switch. Sections of the switch were removed so that the Kapton could be observed. This testing showed that if approximately 5psi vacuum were applied to the SCDS, the Kapton would flip orientation (Figure 6.). After making the determination that the Kapton could flip orientation at a specific vacuum pressure, a series of vehicles were tested to determine what levels of vacuum were generated within their brake systems. Results of this testing showed that there were three levels of vacuum generated among the various Ford model vehicles that were manufactured with TI SCDS. The vacuum levels appeared to be related to the diameter of the master cylinder as the larger diameter master cylinders produced larger vacuums than did the smaller diameter versions. Of the three vacuum levels, two generate greater vacuum pressure than the -5psi required to flip the Kapton orientation. Ambient temperature also influenced the amount of vacuum generated in the brake system. VRTC conducted vacuum tests in a temperature controlled chamber and identified distinct patterns and ranges of vacuum based on vehicle model and ambient temperature (Figure 19.)
