This article supersedes TSB **08-1-9** to update Vehicle Applications, Service Procedure and Part List.

ISSUE

Some 2004-2008 F-150, 2006-2008 Mark LT, 2005-2008 F-Super Duty, Expedition, and Navigator, with 5.4L 3-V engine; 2005-2008 Mustang, 2006-2008 Explorer, Mountaineer, and 2007-2008 Explorer Sport Trac with 4.6L 3-V engine; 2005-2008 F-Super Duty, 2006-2008 and F-Stripped Chassis, with 6.8L 3-V engine may experience difficulty with spark plug removal. This may cause damage to the spark plug and leave part of the spark plug in the cylinder head. Affected engine build dates are as follows: 5.4L 3-V and 6.8L 3-V before 10/9/07, 4.6L 3-V before 11/30/07.

TSB 08-7-6 (Continued)

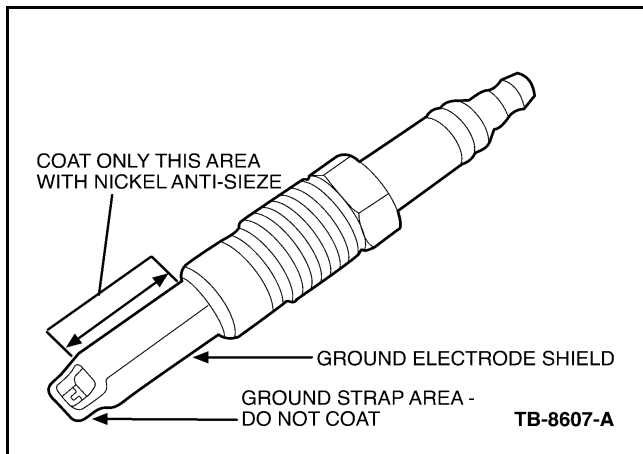
Figure 1 - Article 08-7-6

NEW PLUGS SHOULD BE INSTALLED USING A FILM COATING OF MOTORCRAFT HIGH TEMPERATURE NICKEL ANTI-SEIZE LUBRICANT ON THE GROUND ELECTRODE SHIELD. DO NOT COAT THE ELECTRODE STRAP. (Figure 1)

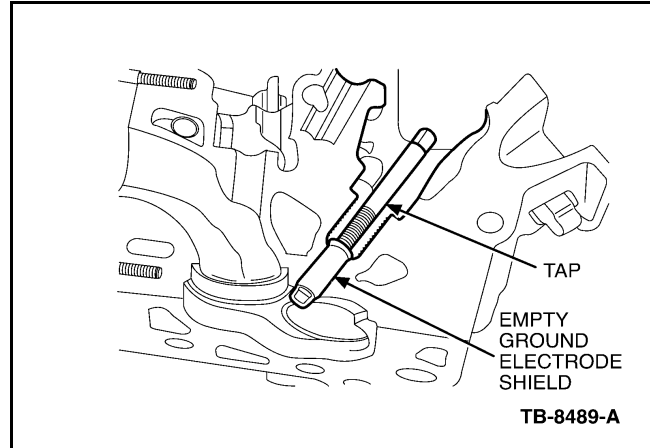
Figure 2 - Article 08-7-6

- a. Mode 1: The ground electrode shield is left behind as an empty shell. (Figure 2)

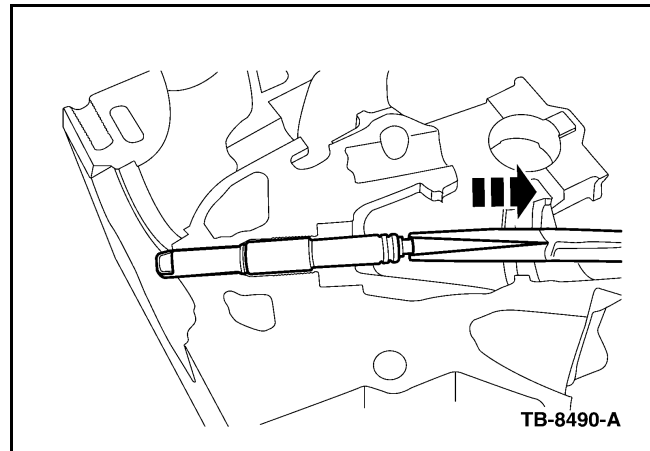
Figure 3 - Article 08-7-6

- b. Mode 2: The entire porcelain insulator and ground electrode shield remains in the cylinder head. (Figure 3)

1. Add an additional 1/2 teaspoon Motorcraft® Carburetor Tune-Up Cleaner fluid into spark plug well and allow 15 minutes of soak time.
2. Using long-reach nose pliers grasp and remove the porcelain with an up and down motion taking care not to fracture the porcelain.

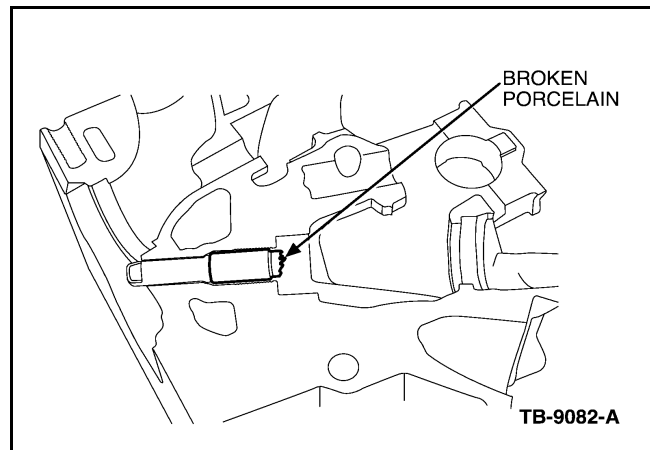
Figure 4 - Article 08-7-6

- c. Mode 3: The upper section of porcelain broke off with remaining porcelain left inside the ground shield. (Figure 4)

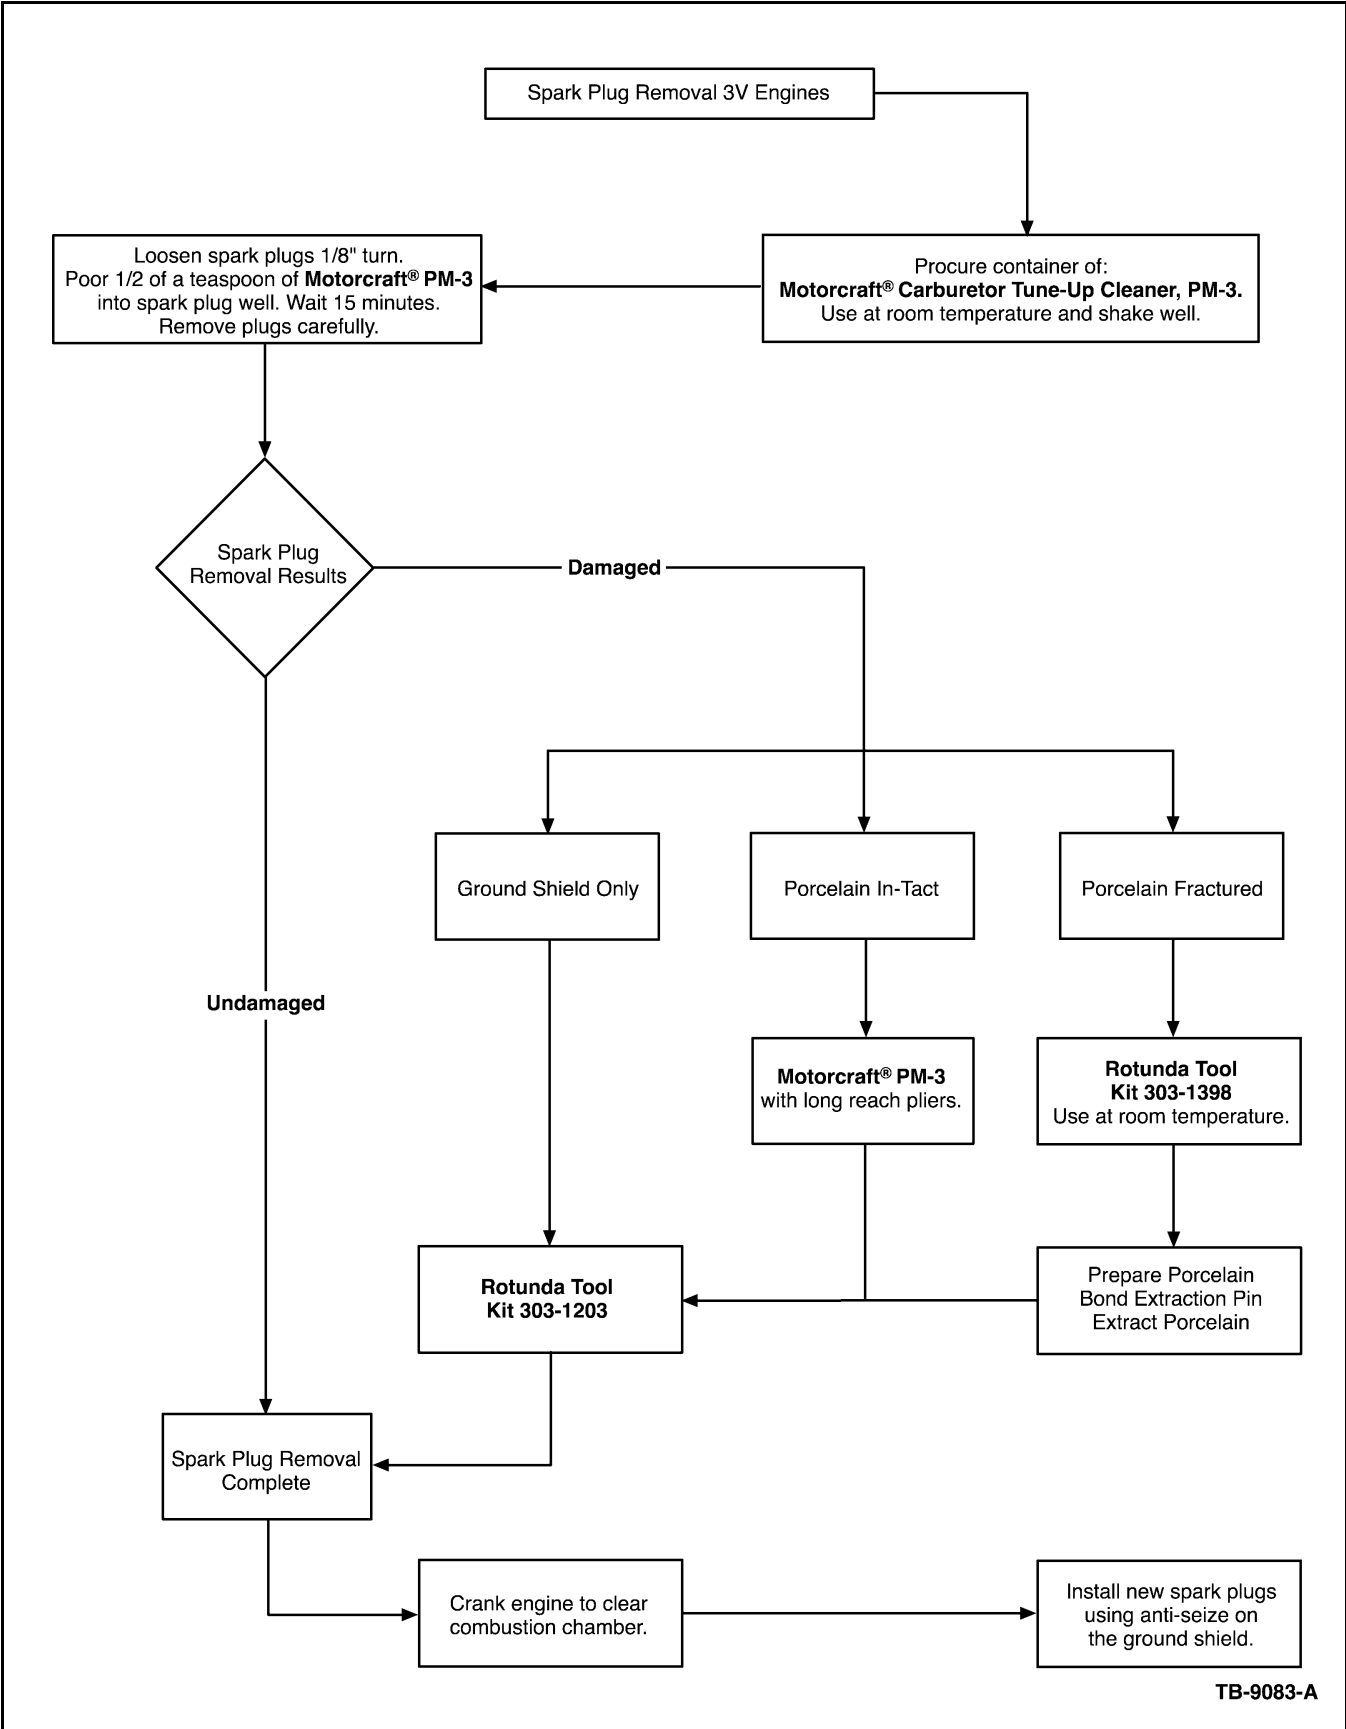
Figure 5 - Article 08-7-6

Flowchart of procedure. (Figure 5)

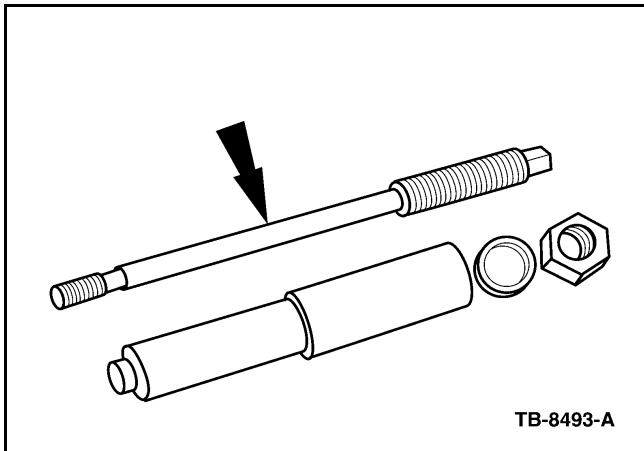
Figure 6 - Article 08-7-6

Use Rotunda special service tool 303-1203 to remove an empty ground electrode shield from the cylinder head. (Figure 6)

THIS TOOL IS ONLY DESIGNED TO WORK WITH AN EMPTY GROUND ELECTRODE SHIELD. IF PORCELAIN REMAINS, PROCEED TO MODE 2 OR 3 REMOVAL.

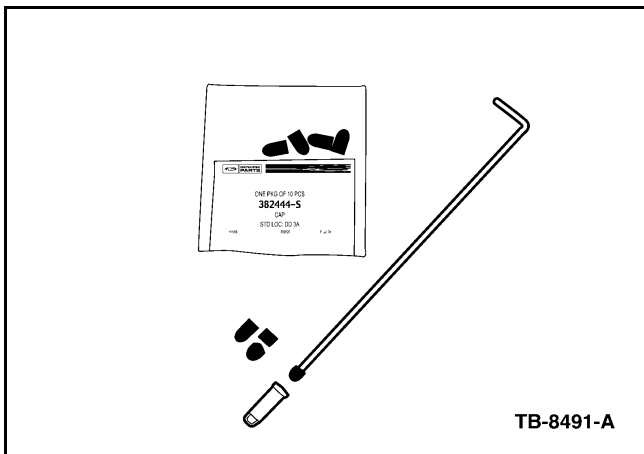
Figure 7 - Article 08-7-6

1. Modify vacuum cap to a 3/8" (10 mm) length for each ground electrode shield that needs to be removed. (Figure 7)

2. Use the installation rod (J) provided with service tool 303-1203 update to install the modified vacuum cap. Push the cap into the ground shield down to the electrode strap. This will plug and protect the combustion chamber from contamination. (Figure 7)
3. Thread-tap the ground electrode shield using a 9.0 x 1.0 mm plug tap (tap profile is about 3-4 reduced diameter threads on the tip end).
 - a. Coat the end of the tap with general purpose grease. (Figure 8)

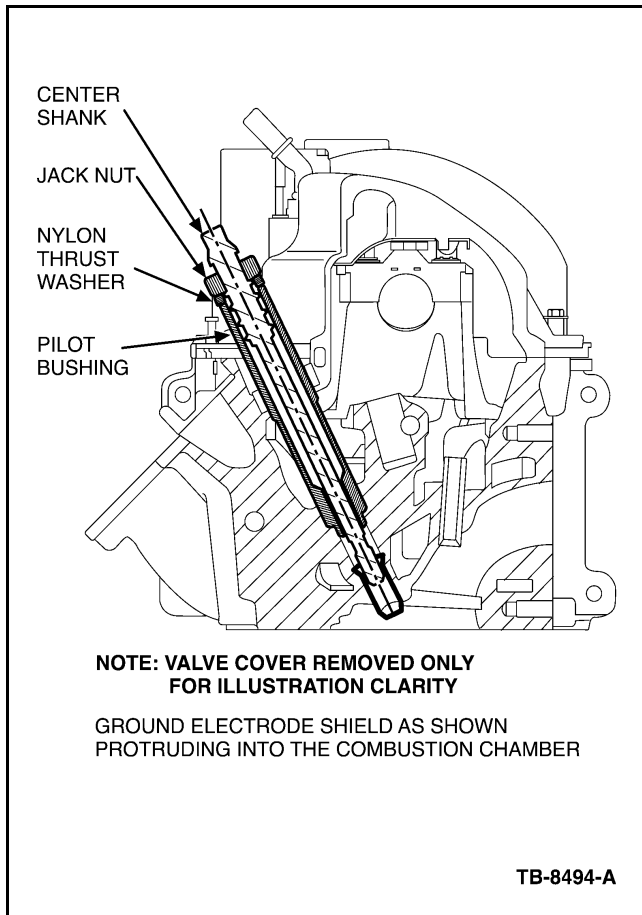
Figure 9 - Article 08-7-6

4. Thread Rotunda special service tool 303-1203 into the ground electrode shield. (Figure 9)

- a. Install the stepped end of the tool pilot bushing into the spark plug well ensuring it bottoms out.
- b. Screw the center shank into the ground electrode shield. Do not over tighten the shank, to prevent thread stripping.
- c. Install the nylon washer and jack nut until finger tight.
- d. Turn the jack nut until the ground electrode is freed from the cavity and withdraw the tool assembly.

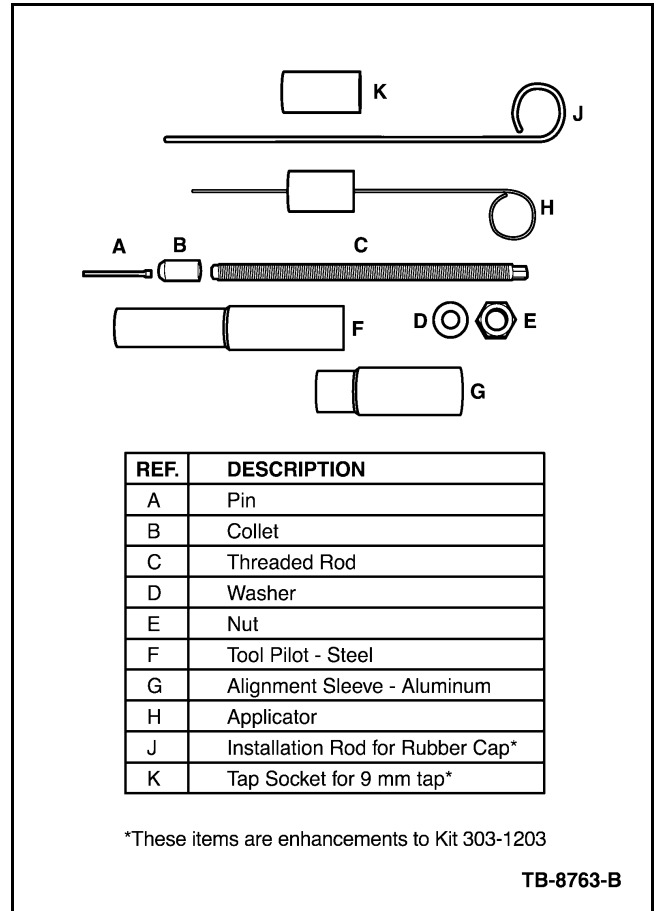
Figure 10 - Article 08-7-6

Use Rotunda special service tool kit 303-1398 to remove porcelain broken inside the ground electrode shield. (FIGURE 10)

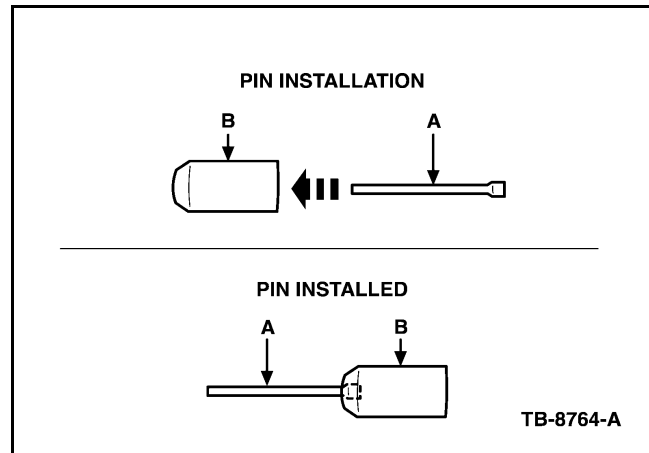
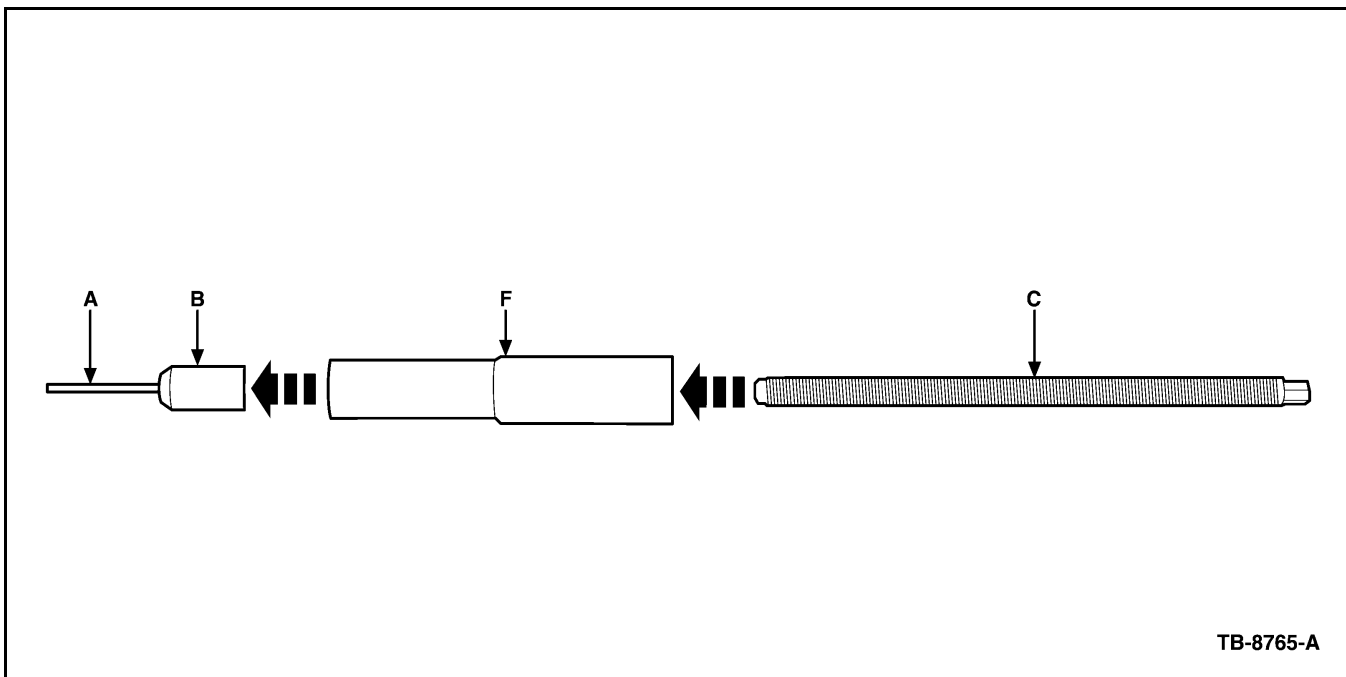
Figure 11 - Article 08-7-6

1. Remove any remaining electrode material from broken porcelain with long nose reach pliers.
2. Spray Motorcraft® Metal Brake Parts Cleaner into the porcelain hole for 2-4 seconds using the straw nozzle supplied with the brake cleaner can.
3. Insert a pin (A) into the collet (B). Screw the collet onto the threaded rod (C). Install the assembled collet, pin, and threaded rod into the steel tool pilot (F). (Figures 11 and 12)

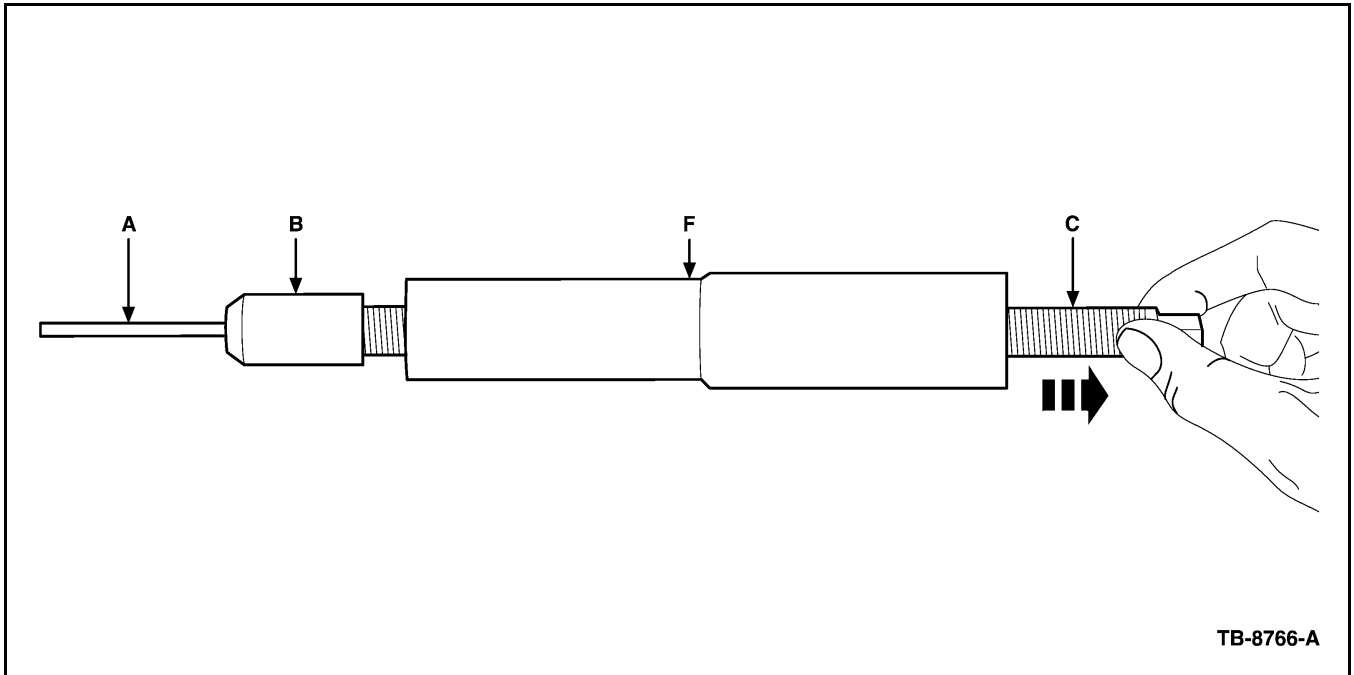
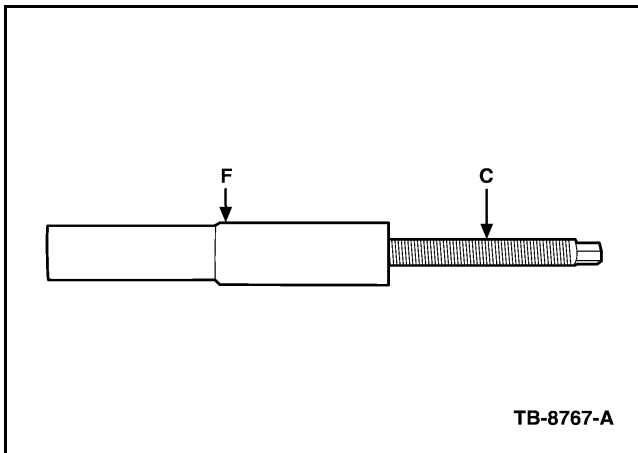
Figure 13 - Article 08-7-6

4. Retract the collet and pin into the steel tool pilot, protecting the pin. (Figures 13 and 14)

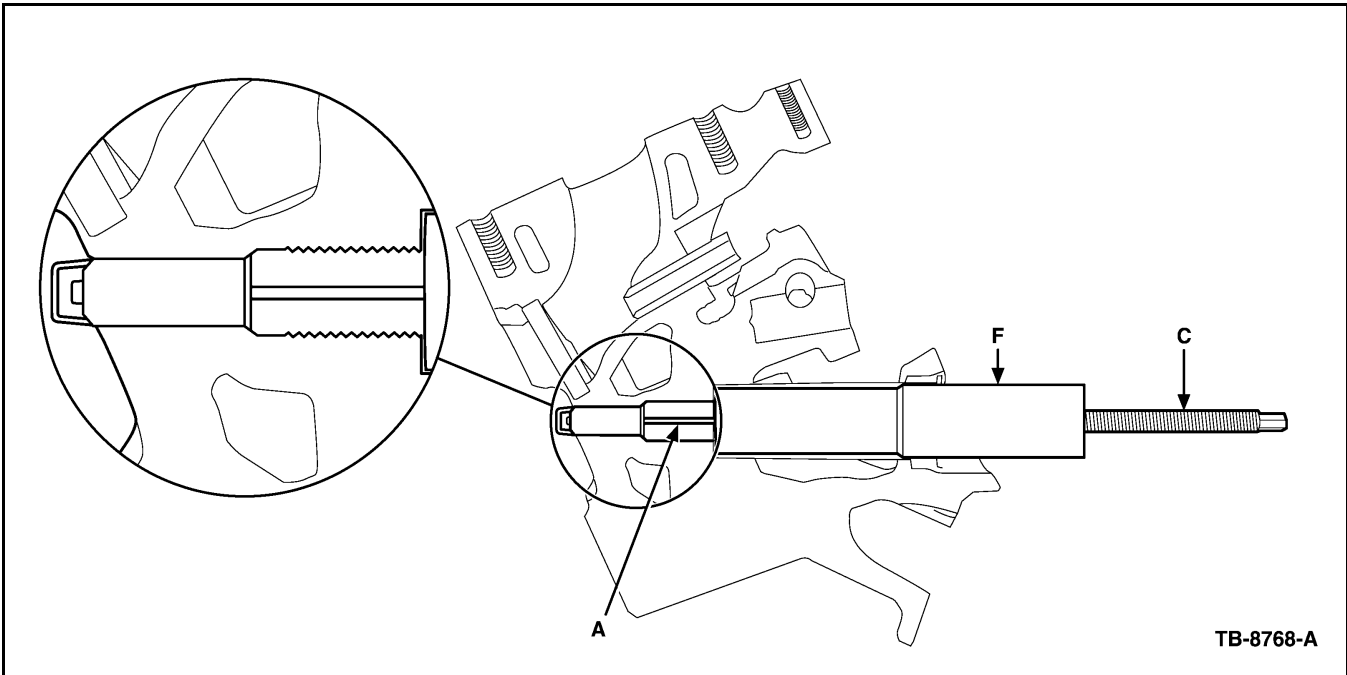
Figure 15 - Article 08-7-6

5. Insert the completed assembly into the spark plug well and fully engage the pin into the porcelain. (Figure 15)

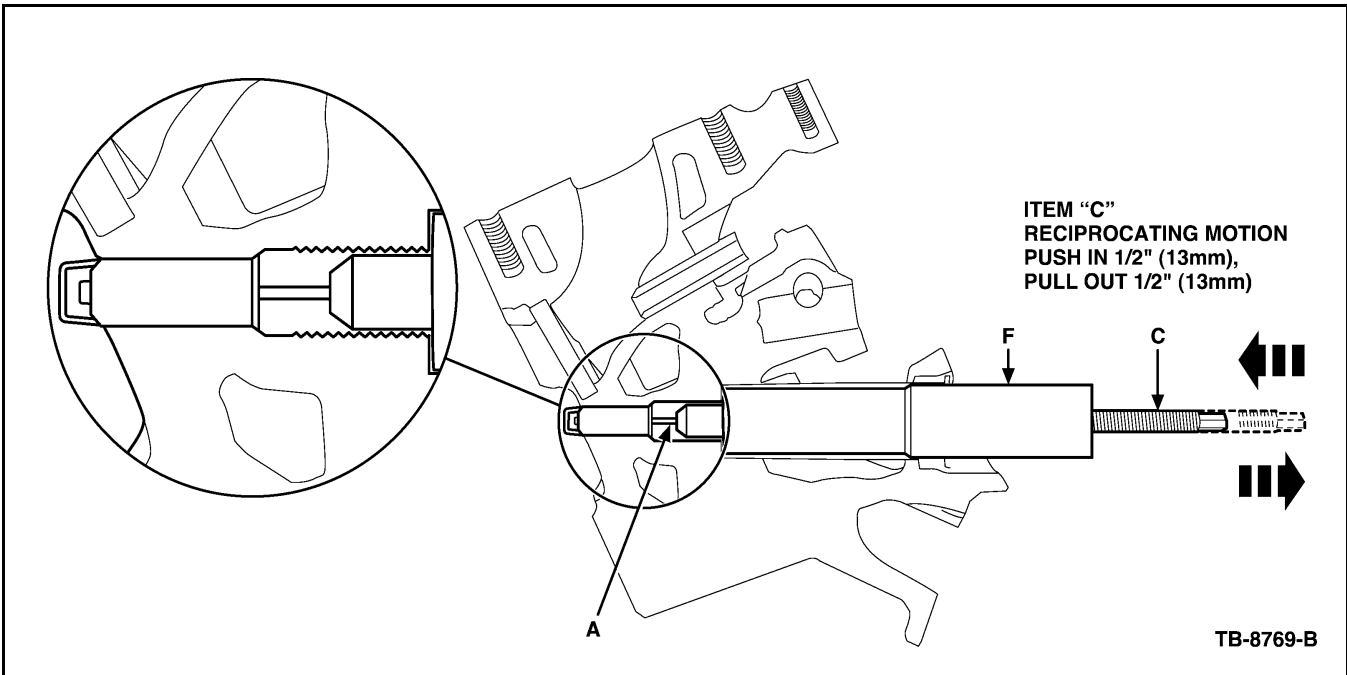
Figure 16 - Article 08-7-6

6. Spray Motorcraft® Metal Brake Parts Cleaner 2-4 seconds between the spark plug well and steel tool pilot. The steel tool pilot must be lifted up approximately 1/2" to allow brake cleaner to flood the porcelain and pin.
7. Scrub the porcelain inside diameter by moving the threaded rod up and down vigorously. Take care making sure the pin does not disengage the porcelain. (Figure 16).

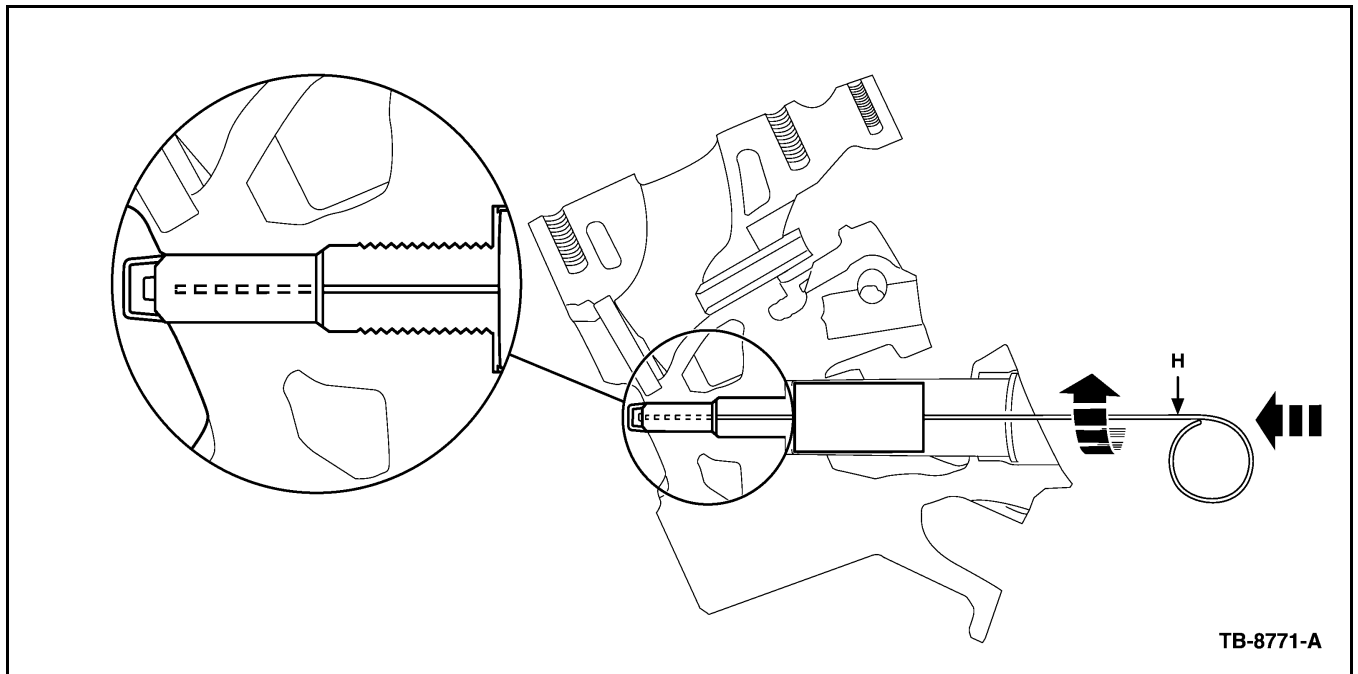
Figure 18 - Article 08-7-6

- Insert applicator into the porcelain and move applicator up and down 1/2" (13 mm) while turning to spread the Loctite® 638™ on the inside of the porcelain. (Figure 18).

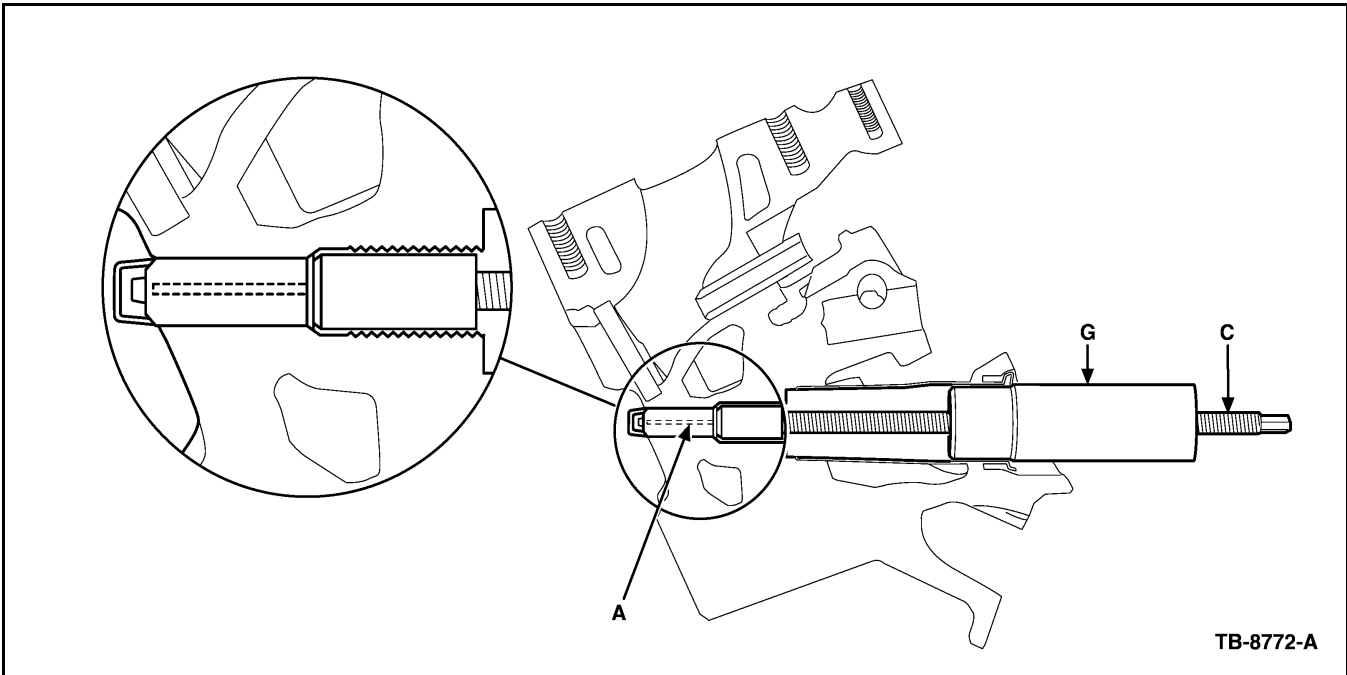
Figure 19 - Article 08-7-6

- Add additional Loctite® 638™, repeating Steps 6-8.
- Leave the pin fully inserted in the porcelain while the adhesive cures. Replace the steel tool pilot with the aluminum alignment sleeve (G), Figure 9, to support the threaded rod while the adhesive cures if additional porcelain fragments are present in other cylinders. (Figure 19).
